# Myre Harbour

Primex International

Environmental ground investigation

DOCUMENT CODE: 713713-RIGm-RAP-001

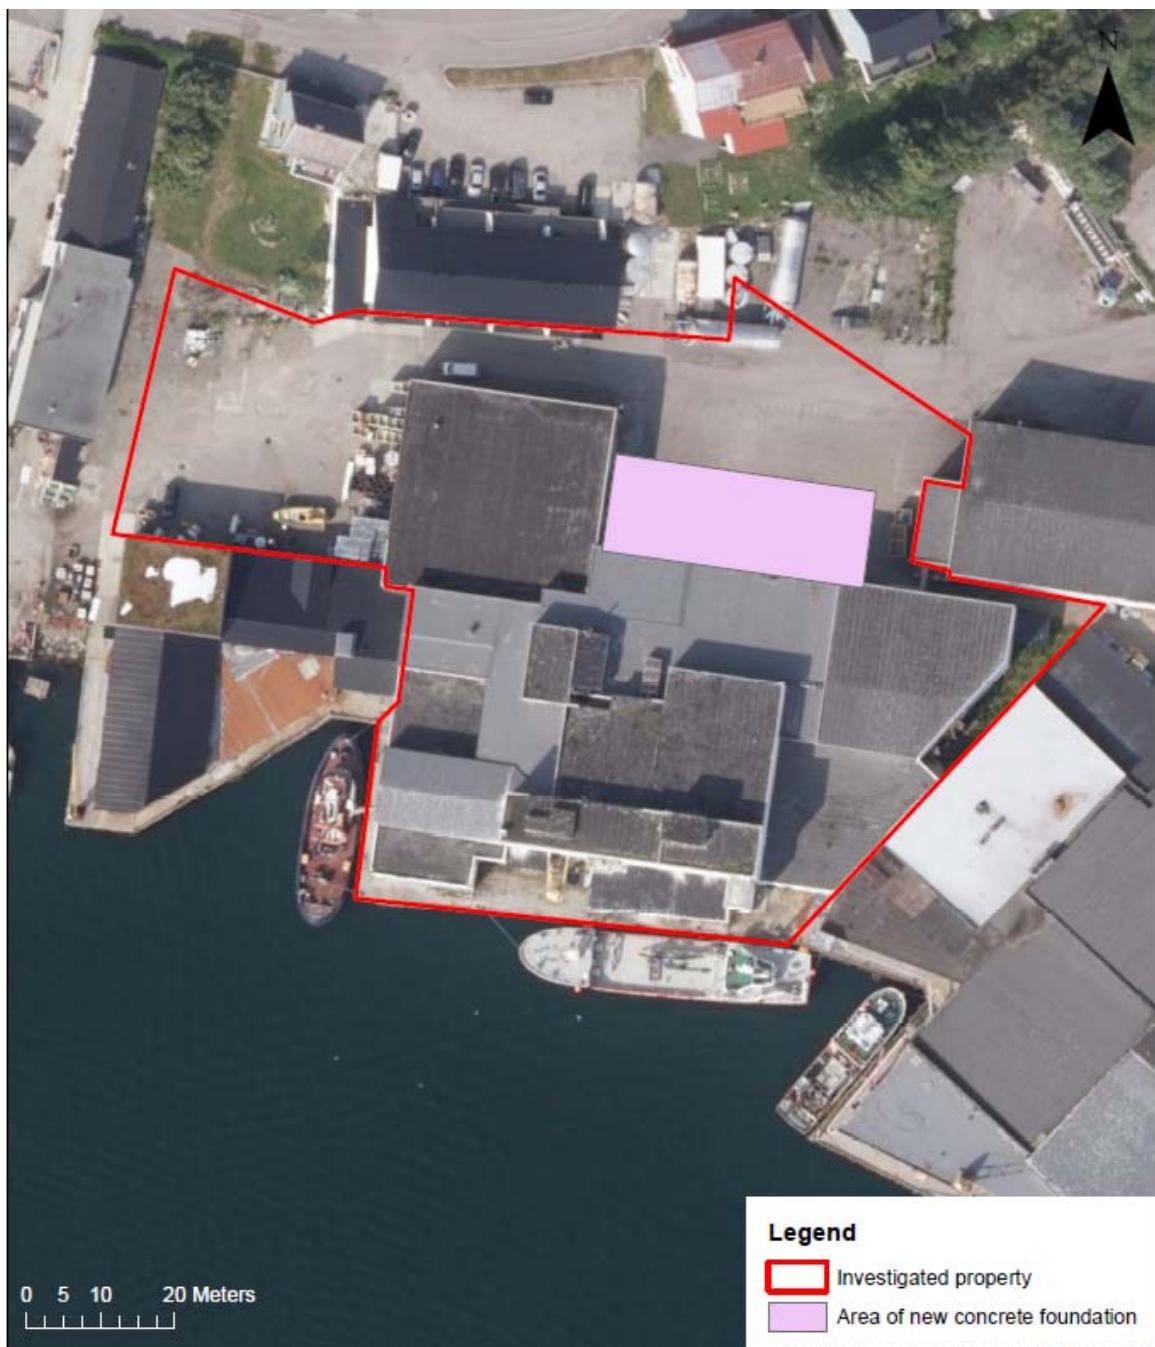
The investigated site is a former fishery, see Figure 2-2. All of the buildings at the site are removed, only the concrete foundation remains. The new fishing station will be established on the existing foundation, and partly on new concrete foundation which will be constructed at the northeastern corner.

Figure 2-2: Havnegata 1, Myre harbour. The investigated site, 65/72, marked with a red line. The buildings shown are removed, and only the concrete foundation remains. Area of new concrete foundation is marked in pink.

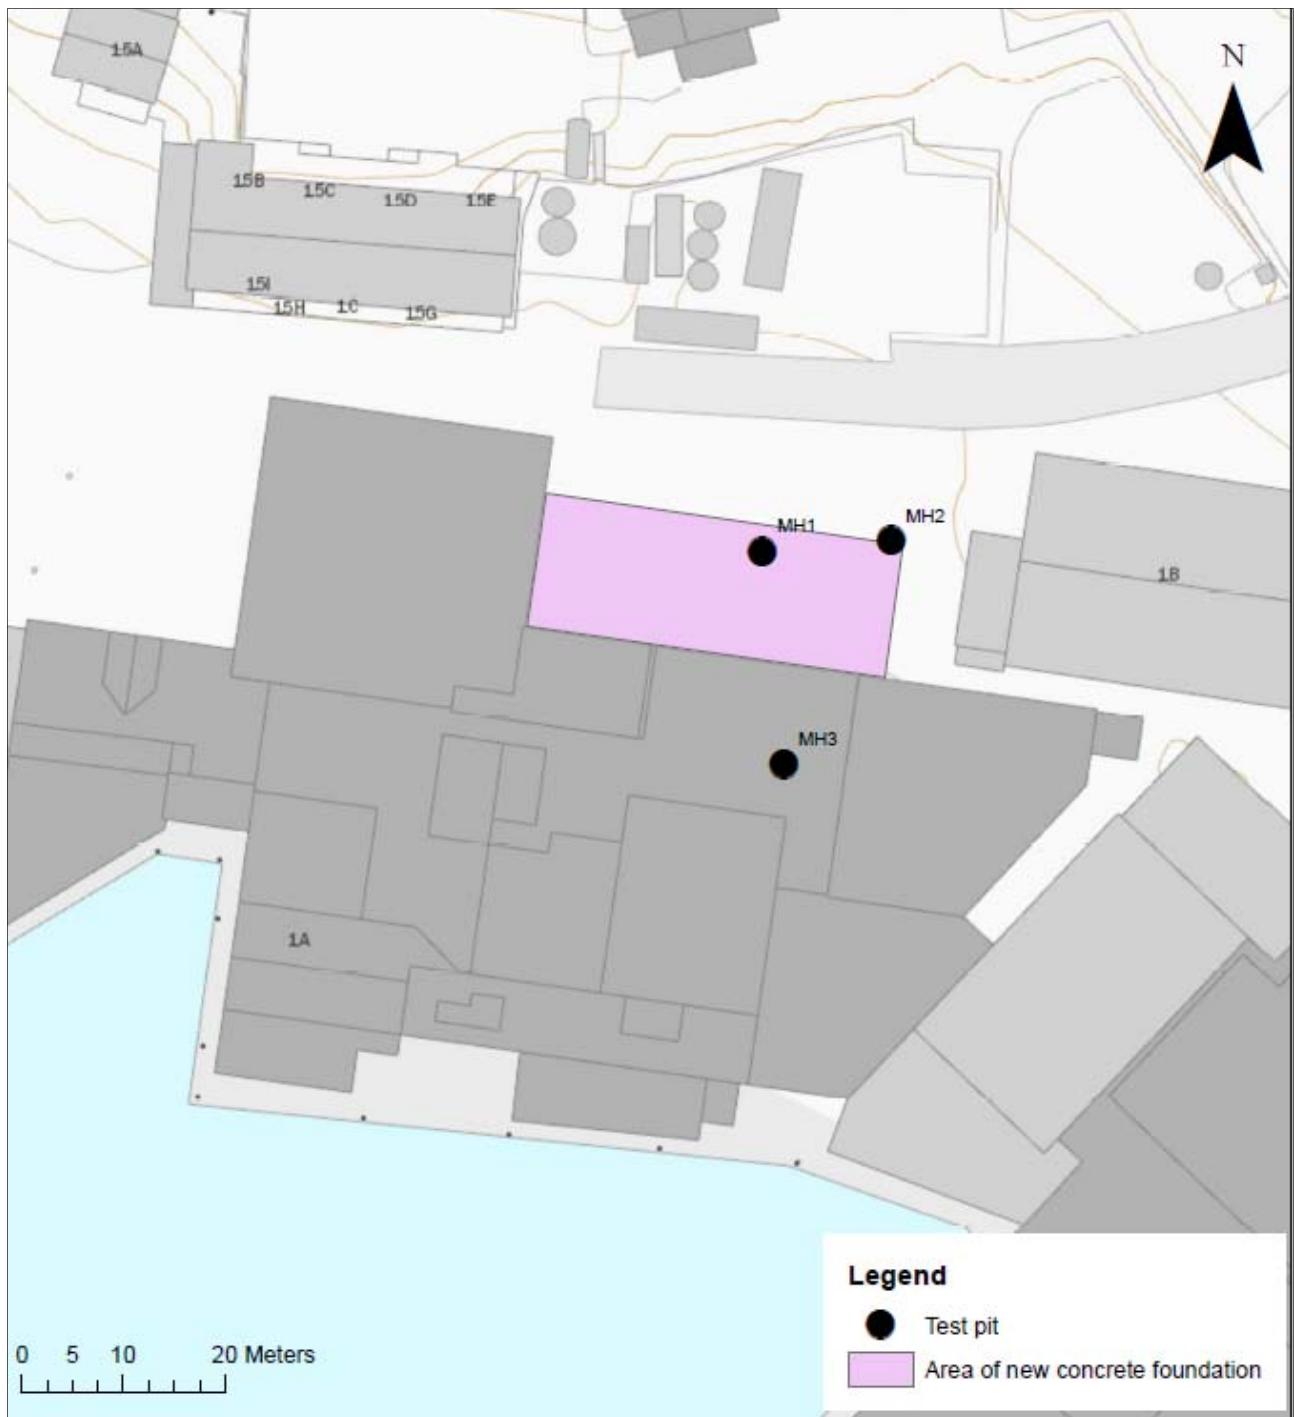
The test pits MH1 and MH2 are located within the area where the new concrete foundation is planned, and MH3 is located within the existing foundation. See Figure 3-1. The test pit locations were measured by the use of GPS.

Figure 3-1: Test pit locations (MH1-MH3). The pink area is where the new concrete foundation is planned.

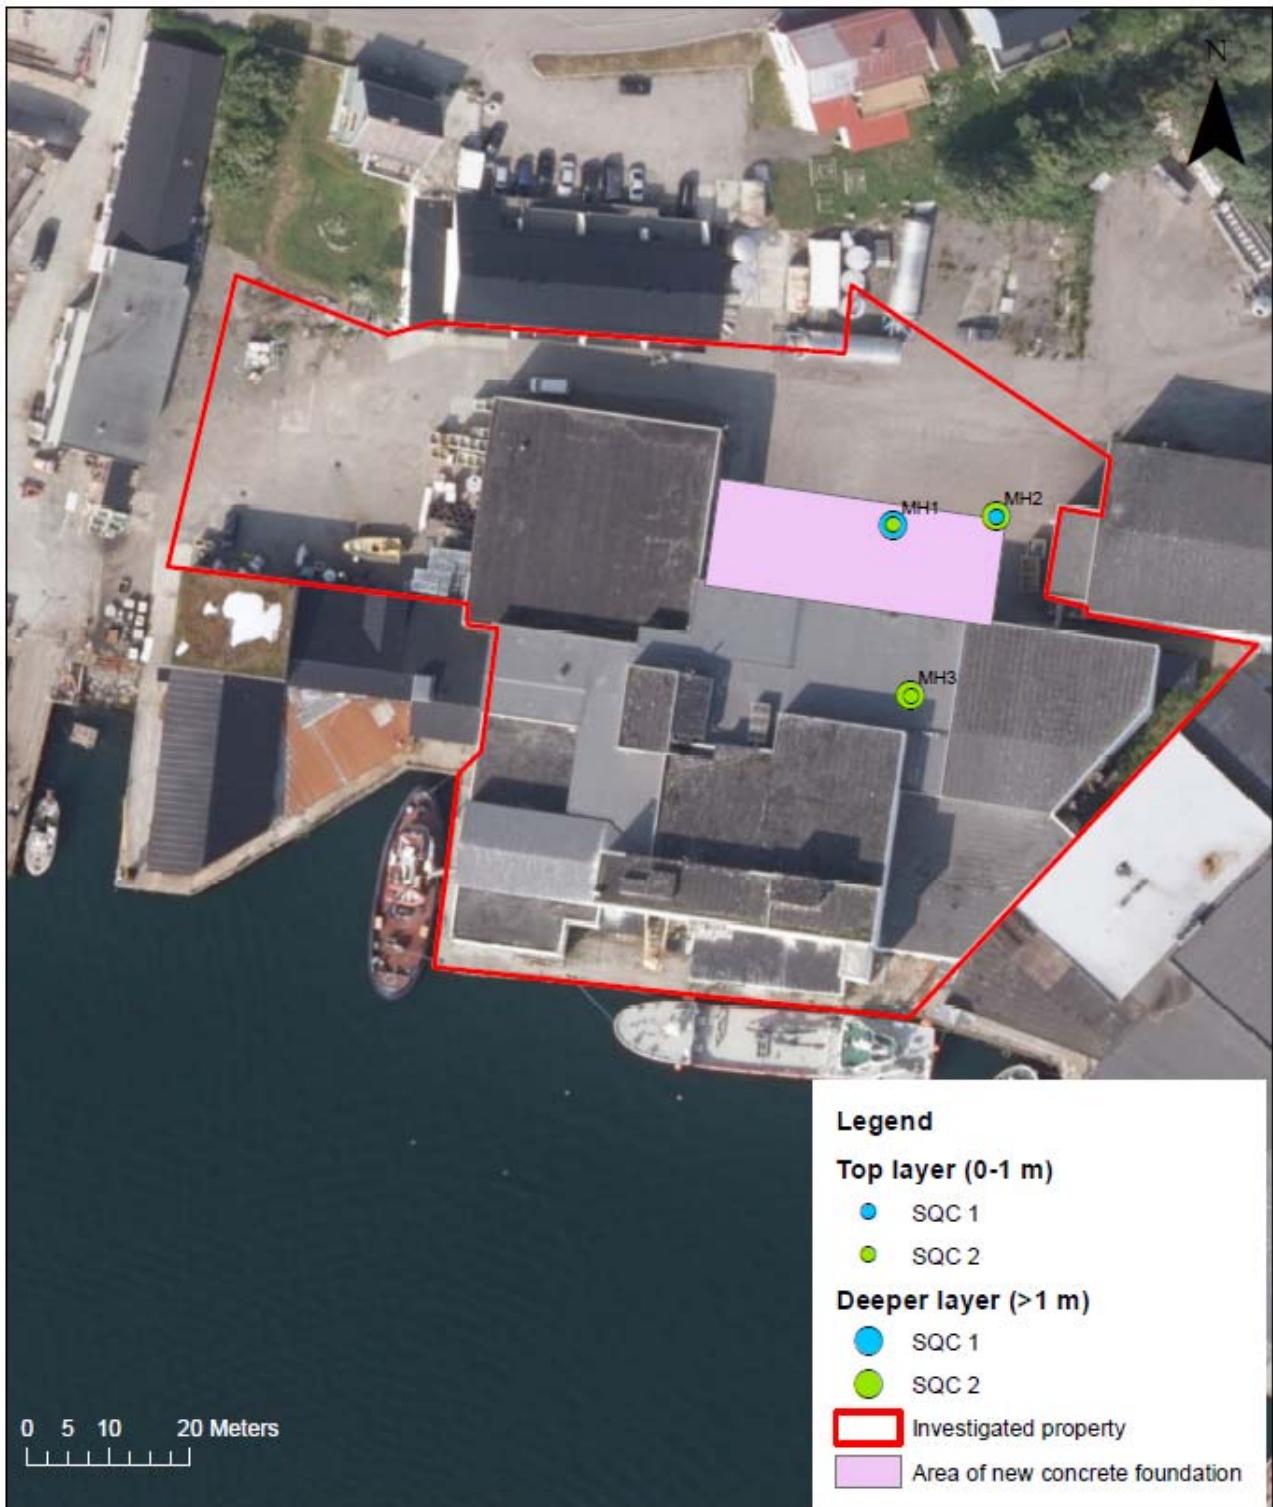
Figure 4-1 presents the sample locations with the maximum contamination levels (SQL) for each test pit, MH1-MH3.

Figure 4-1: Sample locations showing maximum SQC in top soil (0-1 m) and deeper layer (>1 m).

The analytical results shows contamination above SQC 1 in all three test pits. Chromium concentrations according to SQC 2 was identified in the top soil in MH1 and the deeper soil layer in MH2. In MH3, PCBs were detected in both the top and deeper soil layers as well as aliphatic hydrocarbons (C<sub>12</sub>-C<sub>35</sub>) according to SQC 2. All other parameters corresponded to SQC 1, which classifies the investigated soil as "very good" (according to table 4-2).

The investigated area is regulated for industrial purposes. According to the guideline TA-2553/2009, soil quality according to SQC 3 is accepted in top soil for such land use. This means that the investigated soil can remain and be re-used on the site. If the soil is to be removed from the site, it needs to be deposited at an approved waste management facility.
