Åknes Report 04 2010

Hegguraksla in Tafjorden: Monitoring and data analysis

<i>Report number</i>	Åknes 04.2010
<i>Title</i>	Hegguraksla in Tafjorden: Monitoring and data analyses
<i>Authors</i>	Lene Kristensen and Lars Harald Blikra, Åknes/Tafjord Early Warning Centre
<i>Client</i>	Åknes/Tafjord Early Warning Centre
<i>County</i>	Møre og Romsdal
<i>Report date</i>	28.05 2010
<i>Pages</i>	10

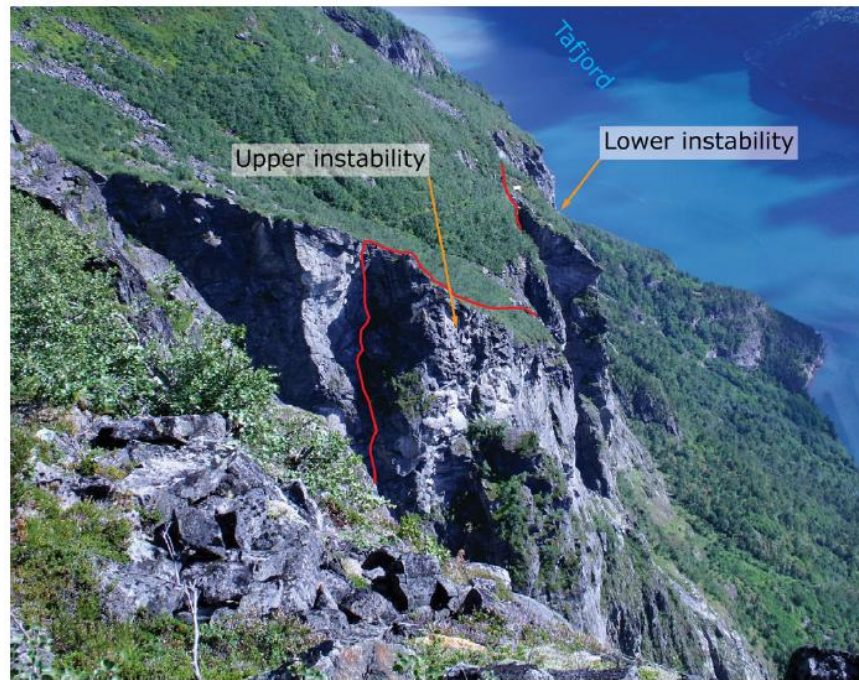
FIGURE 2: VIEW TO THE SOUTHEAST OF THE TWO MONITORED INSTABILITIES AT THE FRONT OF THE HEGGURAKSLA UNSTABLE AREA (FROM OPPIKOFER, 2010).

The lower instability is characterized by a large opening along a back-crack in the northern part (Figure 2). The opening is probably mostly developed by rockfall activity along the highly fractured zone. The back-crack is not visible in the continuation to the south. Water seepage has been observed at the base of the instability (Oppikofer, 2010). The volume of the lower instability has been estimated to be 0,4 mill m³ (Figure 4). Good results were obtained from repeated LIDAR measurements, but a possible movement on the site is smaller than the resolution of the method. A rockfall that occurred between the two datasets from 2007 and 2008, above the open crack, was documented by this method (Oppikofer, 2010).

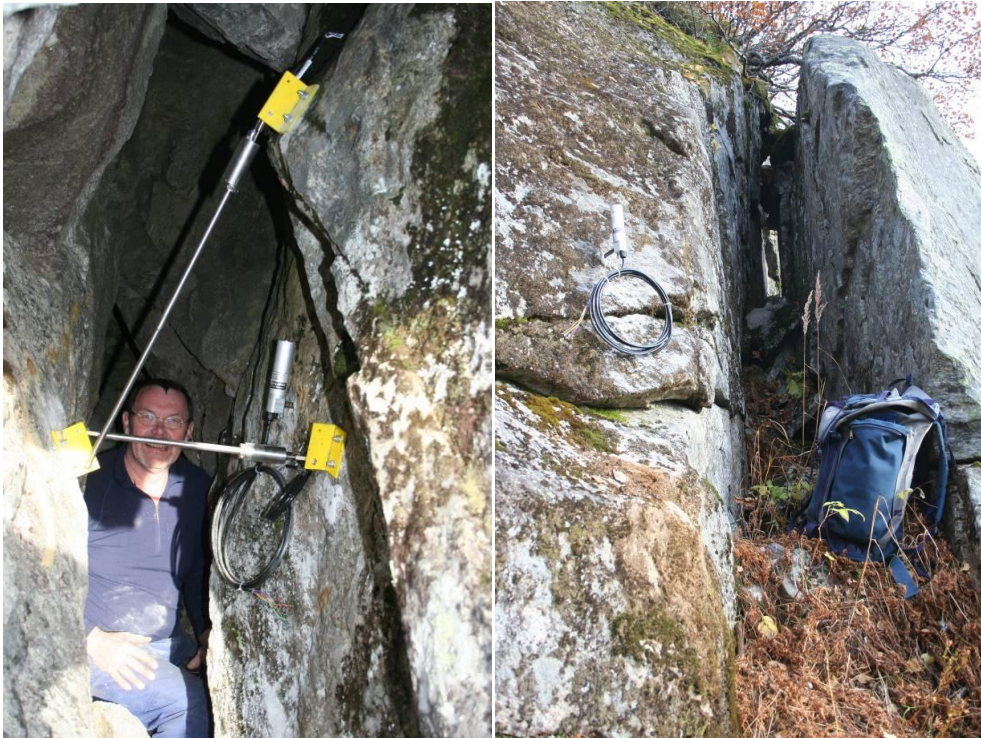
FIGURE 5: CRACKS AND INSTALLATION OF CRACKMETERS AT HEGGURAKSLA.

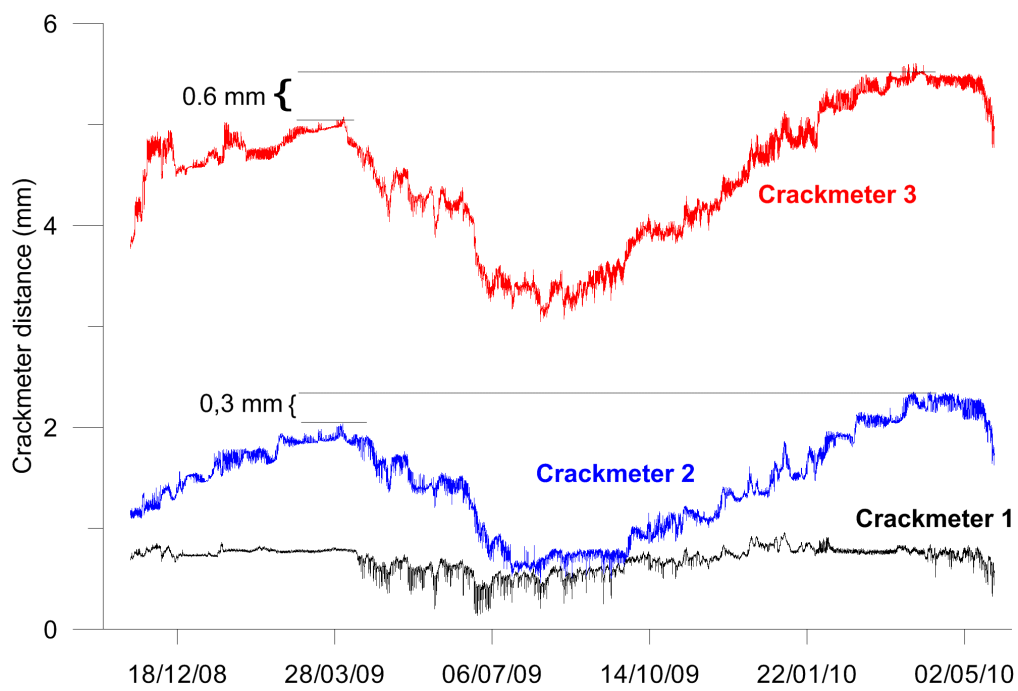
Three crackmeters are installed at the Upper instability. Data from 18th of November 2008 to the 21th of May 2010 is shown in figure 6. Crackmeter 2 and 3 show both a pronounced seasonal cycle, with expansion during winters and contraction during summers. The maximum width of the cracks was greater in the winter 2009-2010 than in the winter 2008-2009. This may either indicate different conditions during the two winters or a general widening of the cracks that is overprinted on a seasonal pattern; however the widening of both crackmeters from one winter to the next was less than 1 mm (Figure 6).

FIGURE 6: CRACKMETERS 1, 2 AND 3, UPPER INSTABILITY, HEGGURAKSLA. EXPANSION IN WINTERS AND CONTRACTION IN SUMMERS ARE SEEN.

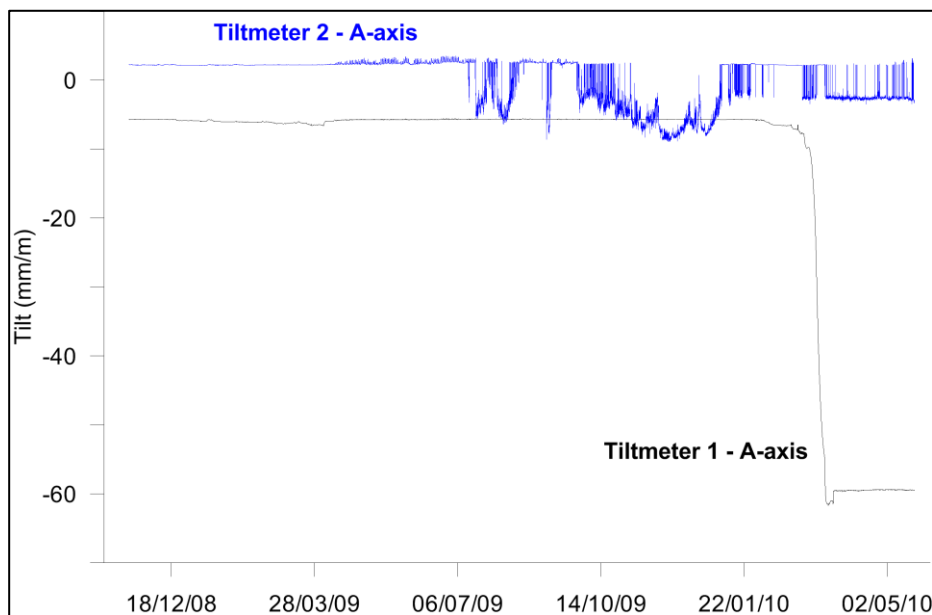
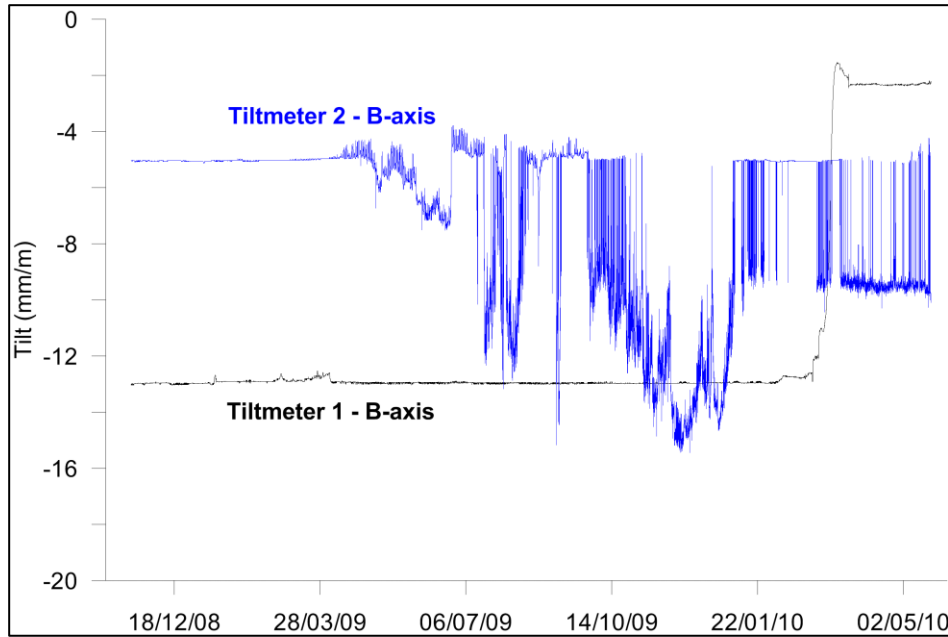
The tilt of tiltmeter 1 is strongly influenced by a sudden event in March 2010, where the tilt changed in A-axis from c. 6 mm/m to 60 mm/m and in the B-axis from -13 mm/m to -3 mm/m (Figures 7 & 8). The event took place over time and may be caused by the displacement of a loose rock, but this need to be followed up more carefully in the field. There are no other indications that there should be movement on this part. Tiltmeter 2 appeared much more stable during the first year but quite unstable since the summer 2009 (Figures 7 & 8).

FIGURE 7: UPPER INSTABILITY, HEGGURAKSLA: TILTMETER 1 AND 2: A-AXIS

FIGURE 8: UPPER INSTABILITY, HEGGURAKSLA: TILTMETER 1 AND 2: B-AXIS.

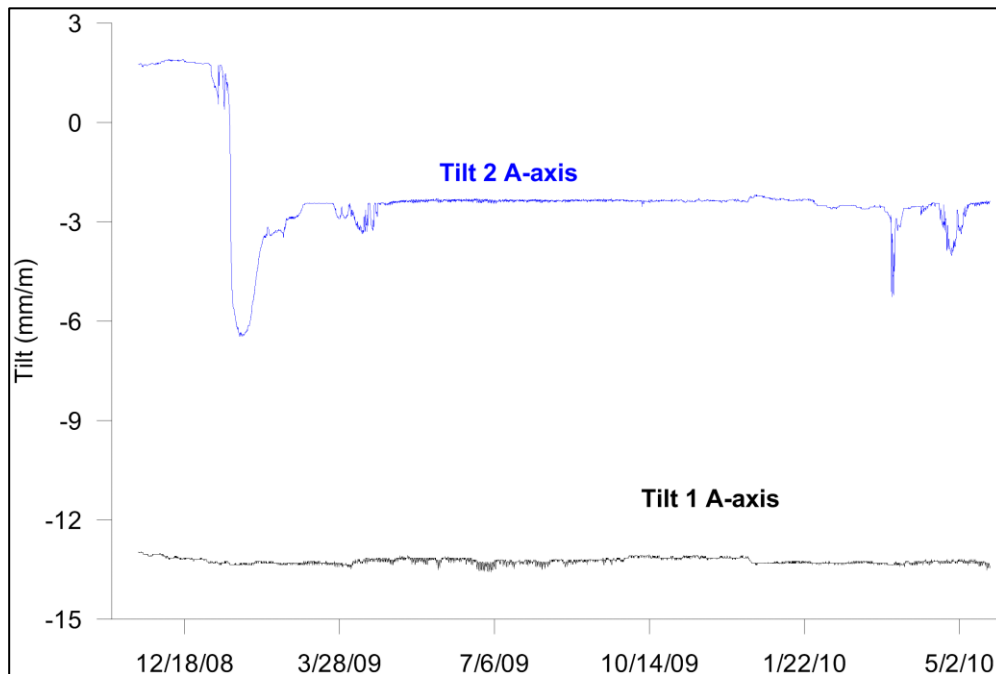
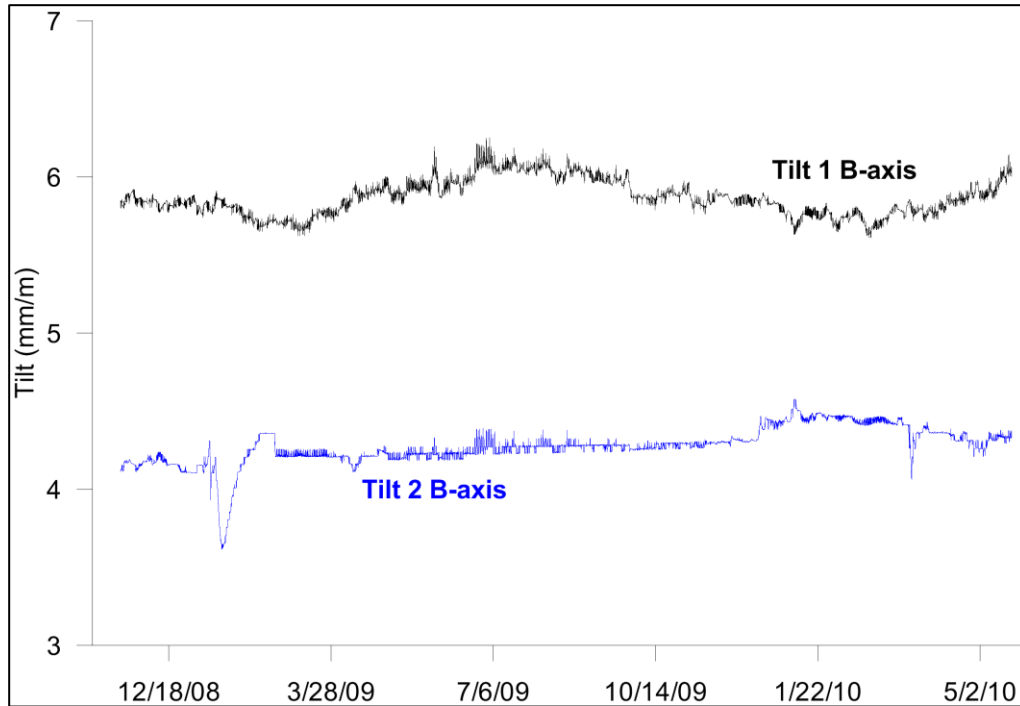
Tiltmeter 1 seems to display a seasonal fluctuation, in particular in the B-axis (Figures 9 & 10). Tiltmeter 2 displays some large jumps, which may indicate that the rock in which it is placed is not stable enough.

FIGURE 9: LOWER INSTABILITY, HEGGURAKSLA: TILTMETER 1 AND 2: A-AXIS.

FIGURE 10: LOWER INSTABILITY, HEGGURAKSLA: TILTMETER 1 AND 2: B-AXIS.

The experienced problems with the radar instrumentation mean that we have no long and reliable time series for analysis. At the moment it does not appear that the tiltmeters provide enough reliable information of displacement of the mountainside. Movement may be too small to be picked up by the tiltmeters or overprinted by other factors that may influence the readings, such as humidity. The crackmeters of the upper instability record a clear seasonal signal of expansion in the winter and contraction in the summer. This suggest that the expansion may be caused by the growth and expansion of ice in the cracks. During two consecutive winters a small overall widening of the cracks was measured (less than 1 mm), but this may reflect unusual conditions during one of these particular winters). The crackmeters appear to be reliable, but they are placed only at the Upper Instability. The instrumentation of Hegguraksla should be supplemented with at least a couple of extensometers, as experience from Åknes has given us greater confidence in these instruments. At least one or two extensometers need to be placed at the lower instability.

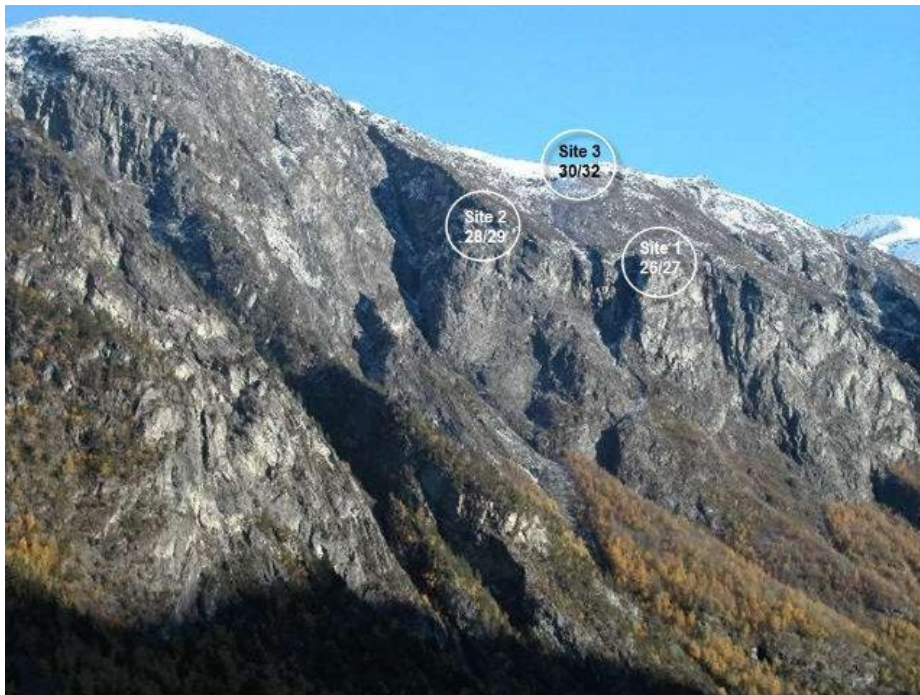
Radar reflectors were placed in 2004, but there have been a series of problems related both to the foundation of the reflectors and to the radar system. Therefore, long-term series cannot be used before the spring 2010. The location can be seen on the photographs in Figure 11, where site 2 is the Upper instability, and Site 1 is the Lower instability. Site 3 above is most likely stable.

FIGURE 11: PHOTO SHOWING THE LOCATION OF THE RADAR REFLECTOR SITES. SITE 2 CORRESPONDS TO UPPER INSTABILITY AND SITE 1 TO LOWER INSTABILITY.

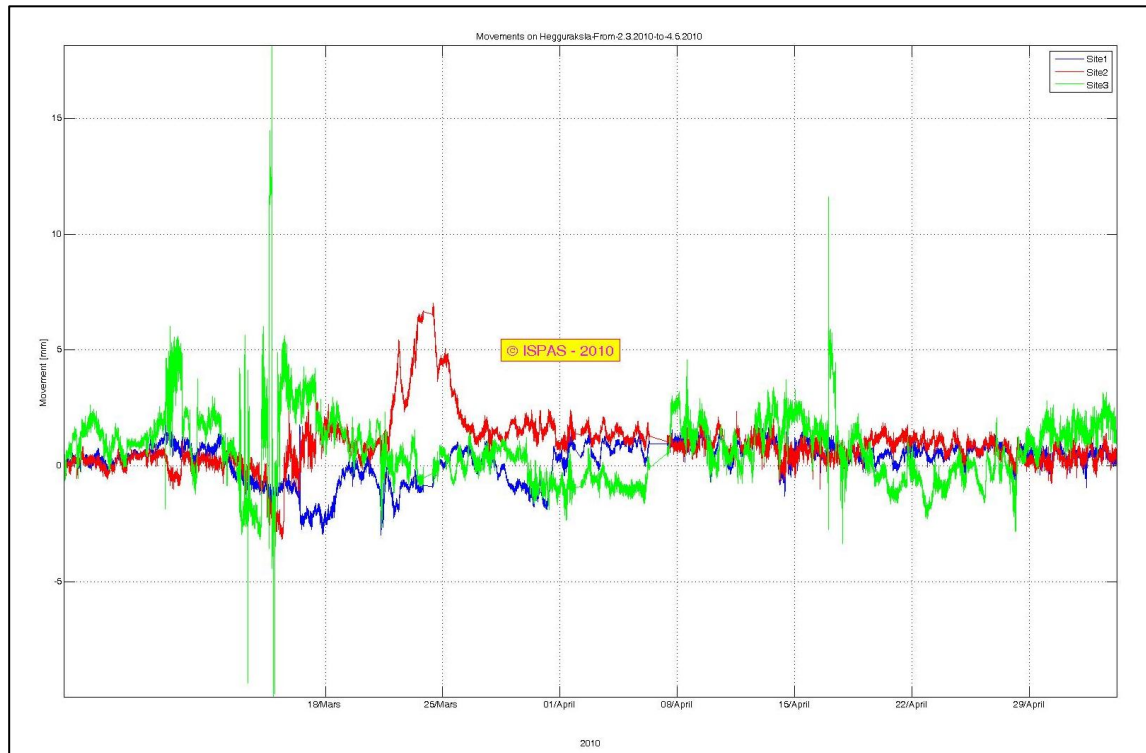
The system should now function better, but we see many jumps (1 - >5mm) in the data (Figure 12). The jumps do not reflect true movement of the rock wall, but rather different atmospheric conditions between the reference and moving reflectors. There also occur some larger jumps of more than 15mm. A Longer time series is necessary before we can properly evaluate possible movement and the system reliability and performance.

FIGURE 12: RADAR MEASUREMENTS AT SITE 1 (BLUE), SITE 2 (RED) AND SITE 3 (GREEN).
