Åknes Report 03 2010

Mannen in Romsdalen: Monitoring and data analyses

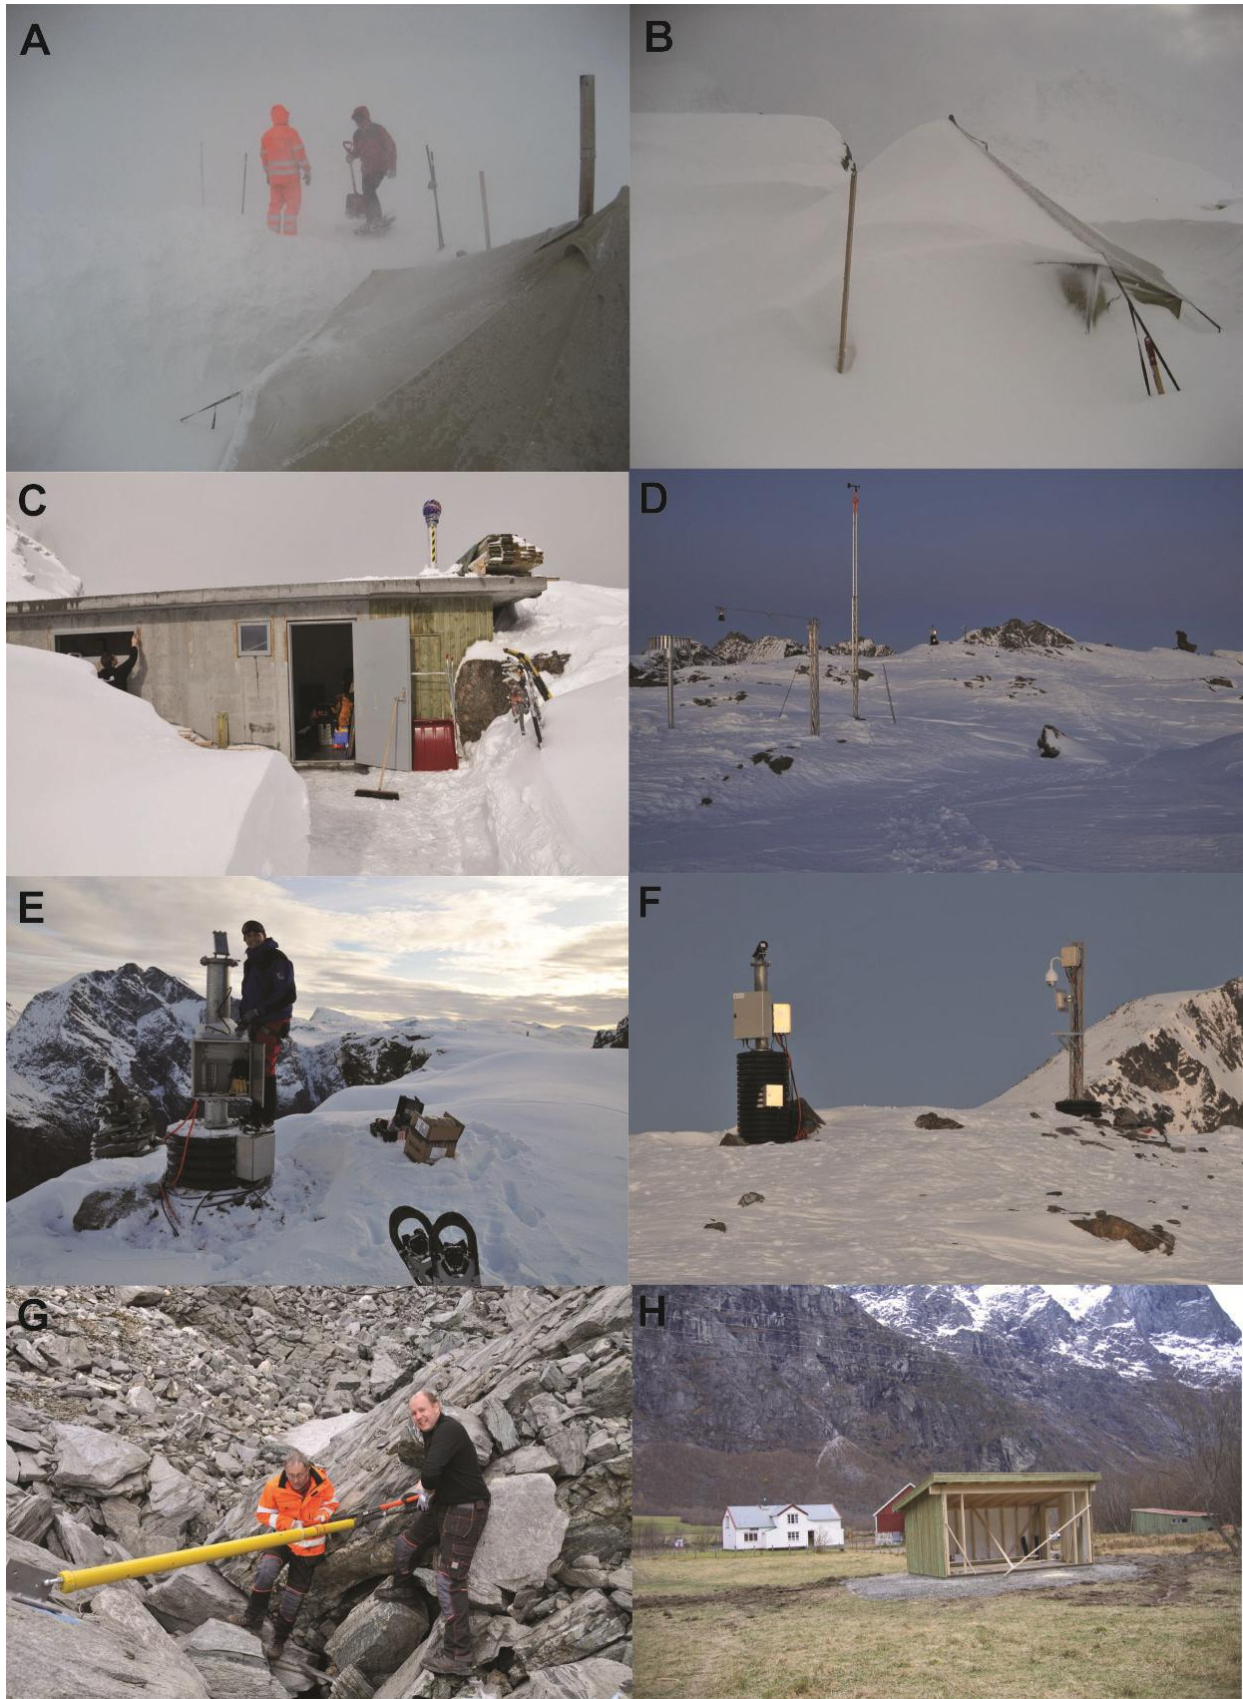
FIGURE 3. PHOTOS FROM ESTABLISHMENT OF DIFFERENT MONITORING ON MANNEN IN 2009. A) AND B) SNOW STORM AND THE TENT CAMP IN OCTOBER; C) BUNKER; D) METEOROLOGICAL STATION; E) ESTABLISHMENT OF LASER SYSTEM LASER SYSTEM; F) LASER TO THE LEFT AND COMMUNICATION ANTENNA AND WEB CAMERA TO THE RIGHT; G) EXTENSOMETER; H) BUILDING FOR THE GROUND-BASED RADAR IN ROMSDALEN.

Instrumentation was initiated at Mannen in the summer/autumn 2009 (Figure 3) and so far the following has been established:

1. Surface monitoring.
 - a. 7 extensometers (Figure 3G & Figure 7)
 - b. 5 tiltmeters (Figure 8)
 - c. 2 single lasers with heated reflector plates (Fig. Figure 3E, Figure 3F & Figure 4)
2. Meteorological station (Figure 3D)
3. Ground-based radar in Romsdalen. (Figure 3H)
4. Bunker with power supply and communication system (Figure 3C & Figure 3F)

Due to an early snowfall in fall 2009, some sensors are still not connected.

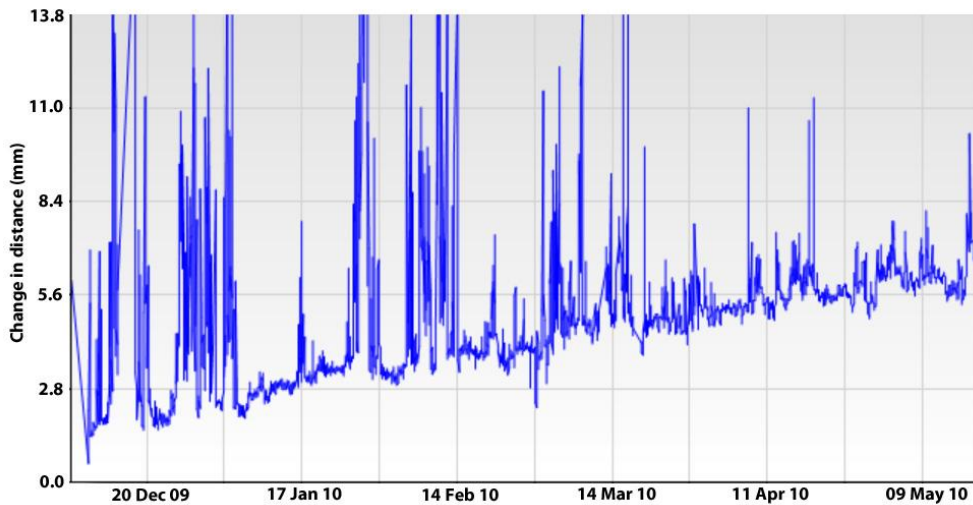
FIGURE 5. LASER 1 FROM 6 DECEMBER TO 21 MAY.

The laser-data contain considerable noise with spikes up to 20 mm, but the many spikes should be overlooked as they are caused by meteorological event. Doing that it is easy to see a clear trend of increased displacements from both lasers. Measured visually on the graph, laser 1 has moved 5.3 mm from the 1th of December 2009 to 21th of May 2010, averaging to 11 mm/yr. Laser 2 has moved 12 mm from the 1th of December 2009 to 21th of May 2010 averaging to 25.6 mm/yr. The movement was largest in the late part of 2009.

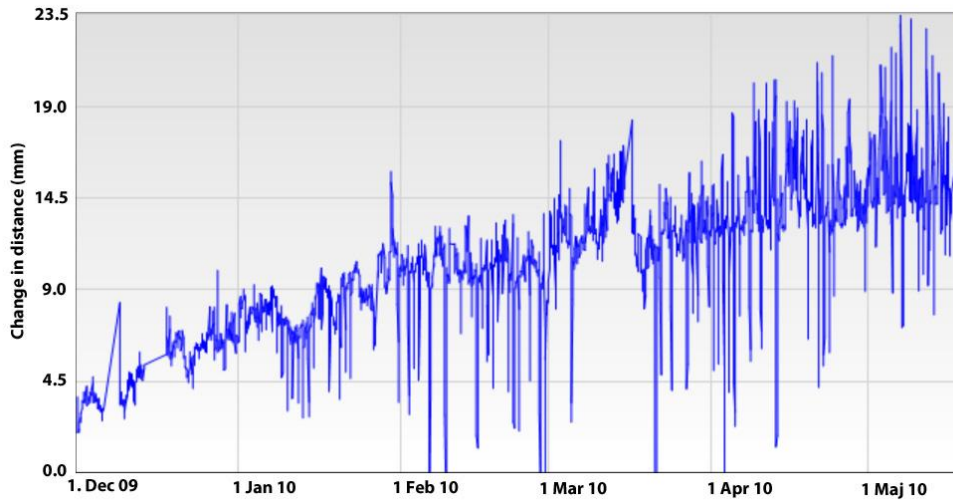
FIGURE 6. LASER 2 FROM 1 DECEMBER 2009 TO 21 MAY 2010.

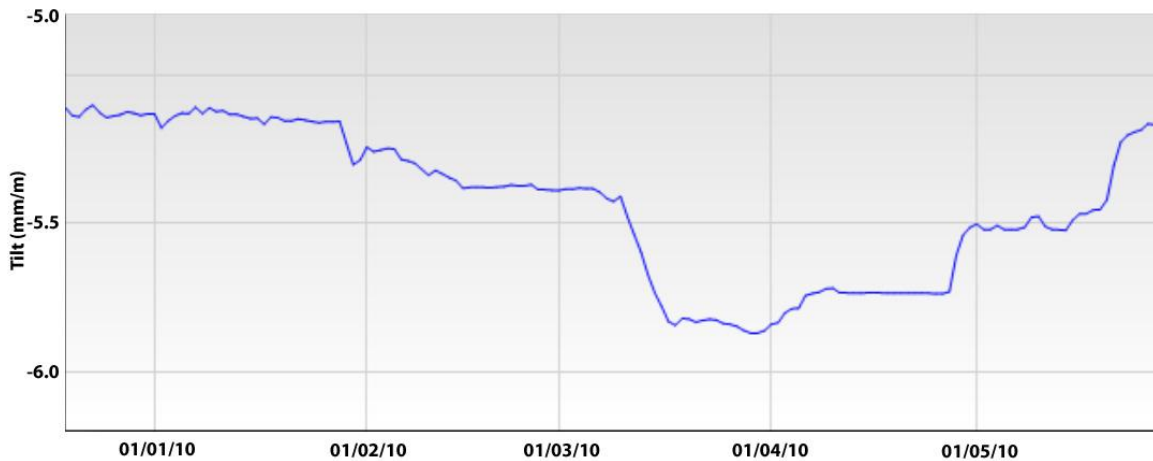
FIGURE 9. ONE WEEK DATA FROM TILTMETER 3, A AXIS (NORTH-SOUTH), AT MANNEN.

Four tiltmeters were established at different places at Mannen (Figure 8). The system has just been implemented in the integrated web-based monitoring system by Cautas Geo. The data seem to be quite stable although no detailed evaluation and interpretation has been performed. The noise level seems to be in the order of 0,2-0,7 mm/m (Figure 9). One of the tiltmeters demonstrates movements in the range of 1 mm in the 5 month measuring period (Figure 9 & Figure 10).

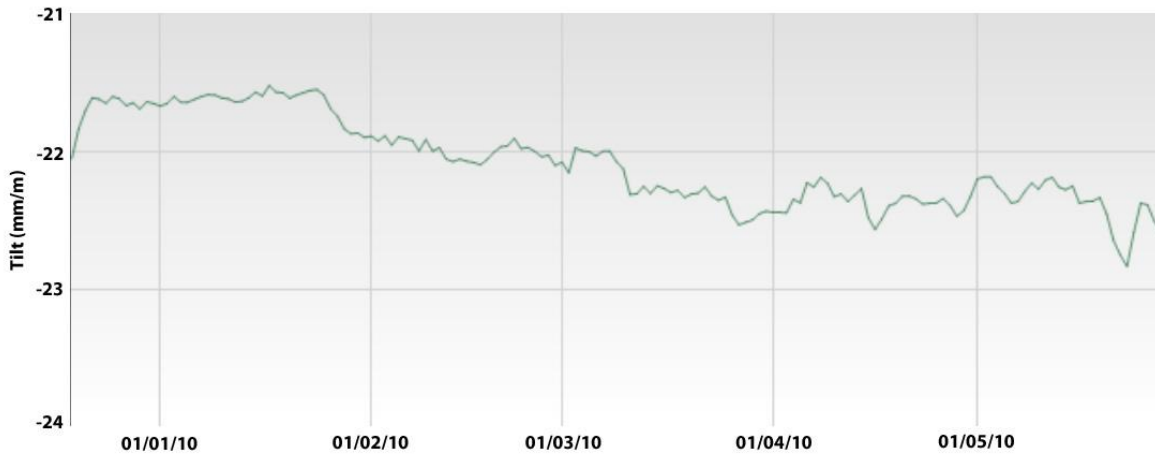
FIGURE 10. DATA FROM TILTMETER 3, B AXIS (EAST-WEST) AT MANNEN IN THE PERIOD FROM THE 18TH OF DECEMBER TO THE 28TH OF MAY 2010.

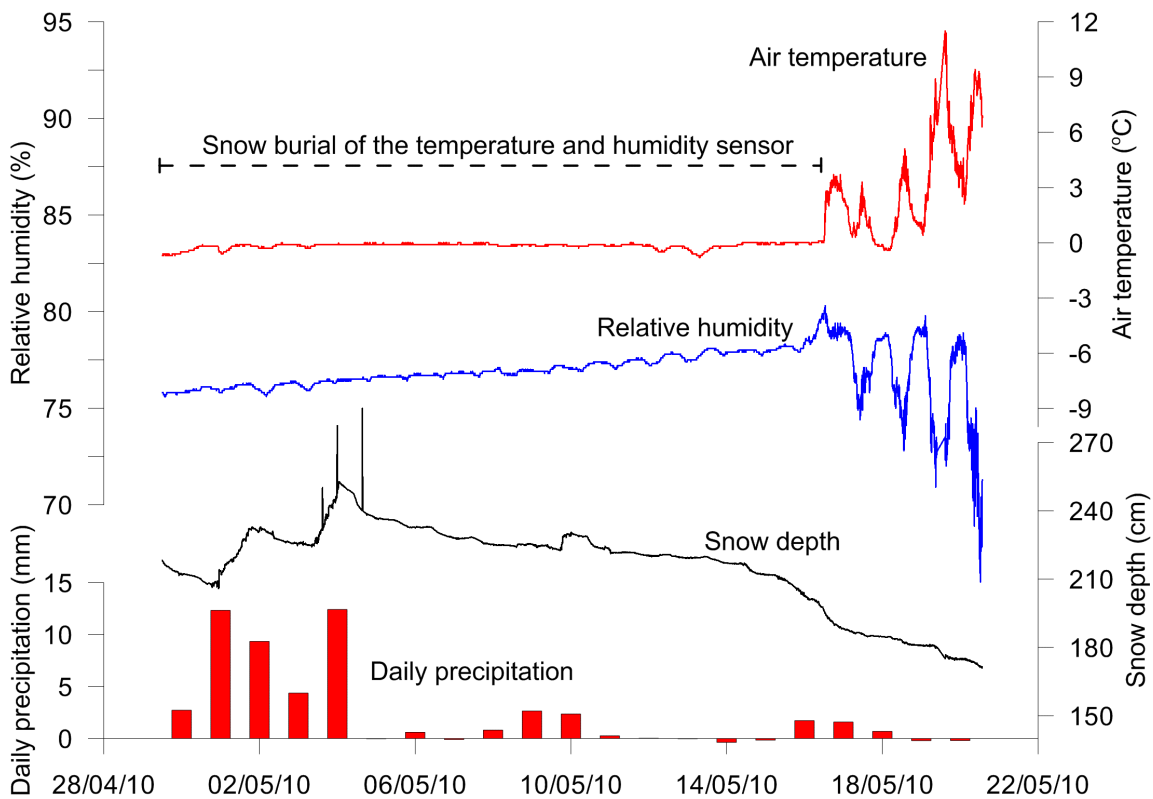
FIGURE 11. DATA FROM THE METEOROLOGICAL STATION AT MANNEN.

A meteorological station was established by the Norwegian meteorological Institute in autumn 2009, but was not connected correctly to the datalogger before 29th of April 2010. More snow than expected built up during the winter, and buried the air temperature and humidity sensors and almost the precipitation sensor, resulting in almost constant readings until 16 May (Figure 11) reflecting only in-snow conditions. The sensors will be placed higher in the summer 2010. Figure 11 shows only a few days of good measurements, after the snow had disappeared from the sensors.

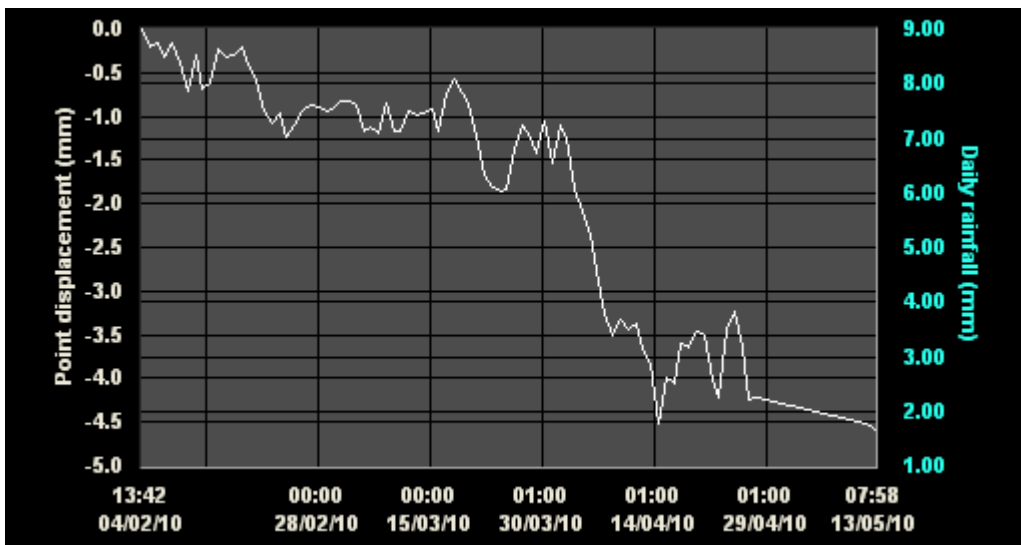
FIGURE 14. DISPLACEMENT OF POINT 7 INDICATING MOVEMENT OF 4 TO 5 MM FROM THE 2ND OF FEBRUARY TO THE 13TH OF MAY.

The locations of the points of interest can be seen on Figure 13 and a plot of the displacement of the points is shown in Figure 14. So far it is difficult to evaluate the performance of the radar. However, some of the individual points shows a displacement of up to 4,5 mm during 3 months, which is comparable of what has been seen from the laser measurements.

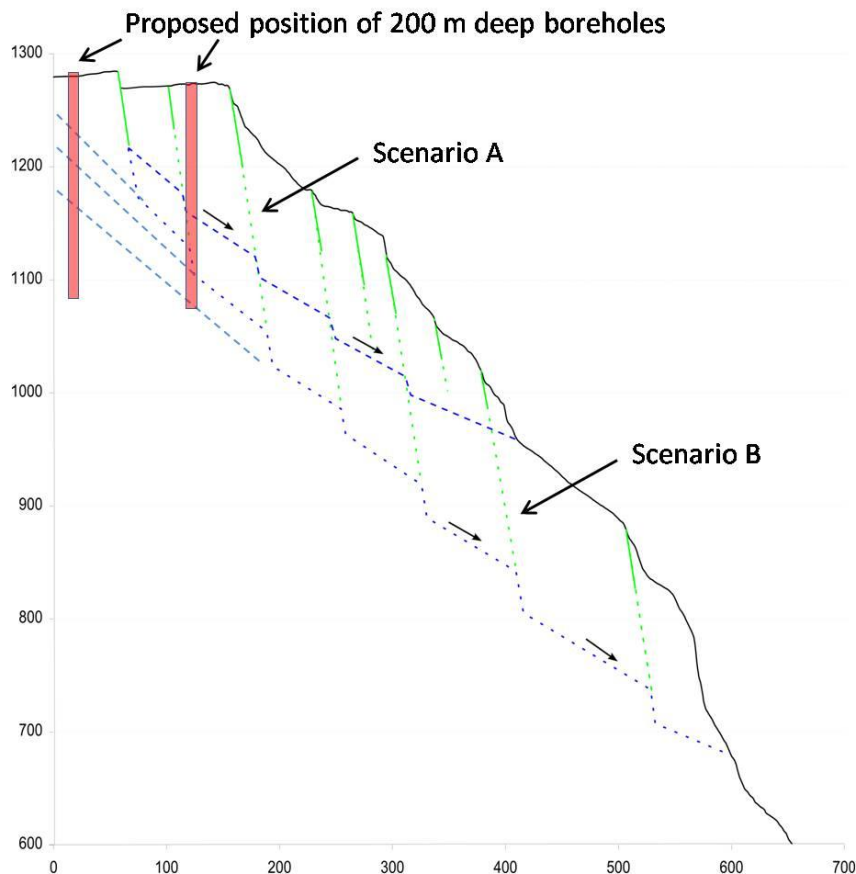
FIGURE 16. TENTATIVE POSITION OF THE BOREHOLES ON A SCHEMATIC CROSS PROFILE. BOREHOLE LOCATION FURTHER DOWN THE SLOPE WILL BE EVALUATED DURING THE SPRING 2010.

Boreholes are important in order to identify sliding planes and understand the dynamics of the rockslide, but are also a very reliable system for early warning. In this area we may also have permafrost conditions, which complicate the understanding of the kinematics. It is proposed to have one borehole on the moving block, and one on the backside, but still within open fracture systems (Figure 15 and Figure 16). If practical possible, a borehole further down the slope should be prioritized before the borehole on the topmost part. The boreholes will be logged by different geophysical methods before establishment of casing and instrumentation (DMS column).
