Åknes Report 04 2010

Hegguraksla in Tafjorden: Monitoring and data analysis

<i>Report number</i>	Åknes 04.2010
<i>Title</i>	Hegguraksla in Tafjorden: Monitoring and data analyses
<i>Authors</i>	Lene Kristensen and Lars Harald Blikra, Åknes/Tafjord Early Warning Centre
<i>Client</i>	Åknes/Tafjord Early Warning Centre
<i>County</i>	Møre og Romsdal
<i>Report date</i>	28.05 2010
<i>Pages</i>	10

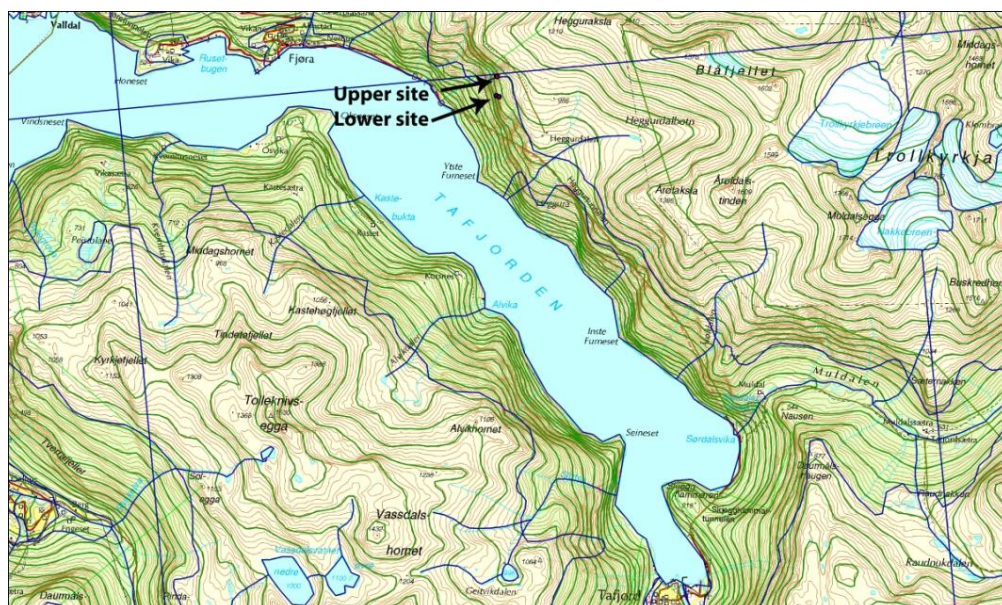
FIGURE 1: THE POSITION OF THE TWO INSTABILITIES AT HEGGURAKSLA IN TAFJORDEN, INNER STORFJORDEN.

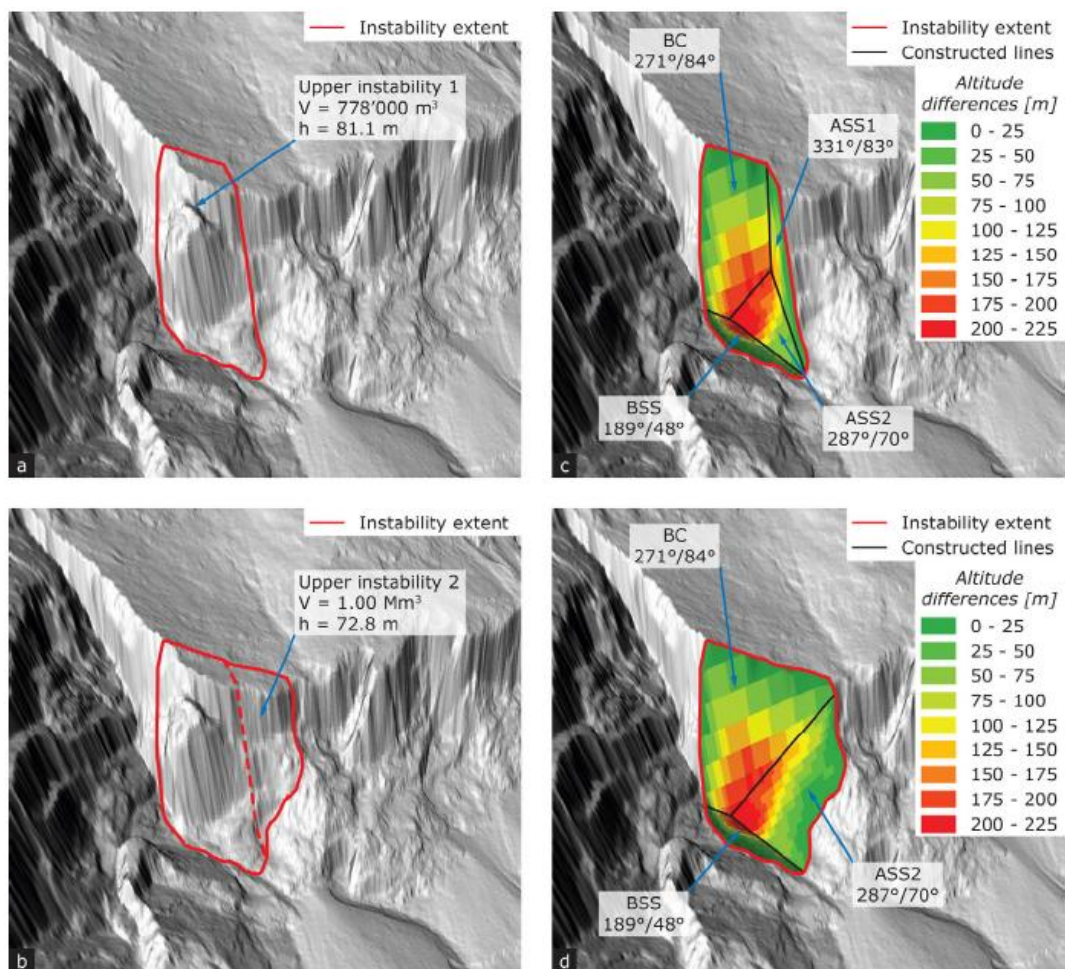
The upper instability is a 250 m high column composed of two lithologies; orthogneisses in the lower part and augengneisses in the upper part (Oppikofer, 2010). A large open NNE-SSW-trending fracture acts as back-crack, and this fracture can be followed further to the south and is marked in the field by a small escarpment. Oppikofer proposed two alternative interpretations of the geometry (Figure 3). The volume estimates for the unstable blocks is 0,8 and 1,0 mill m³ for the two alternatives respectively. Large problems due to difficult atmospheric conditions were affecting the LIDAR measurements (Oppikofer, 2010), and conclusions of possible movements cannot be drawn from these investigations.

FIGURE 3: 3D REPRESENTATIONS OF THE HEGGURAKSLA AREA (FROM OPPIKOFER, 2010). A & B: TWO POSSIBLE GEOMETRIES OF THE UNSTABLE BLOCKS; C & D: BASAL FAILURE SURFACE AS THE BASE FOR VOLUME ESTIMATIONS.

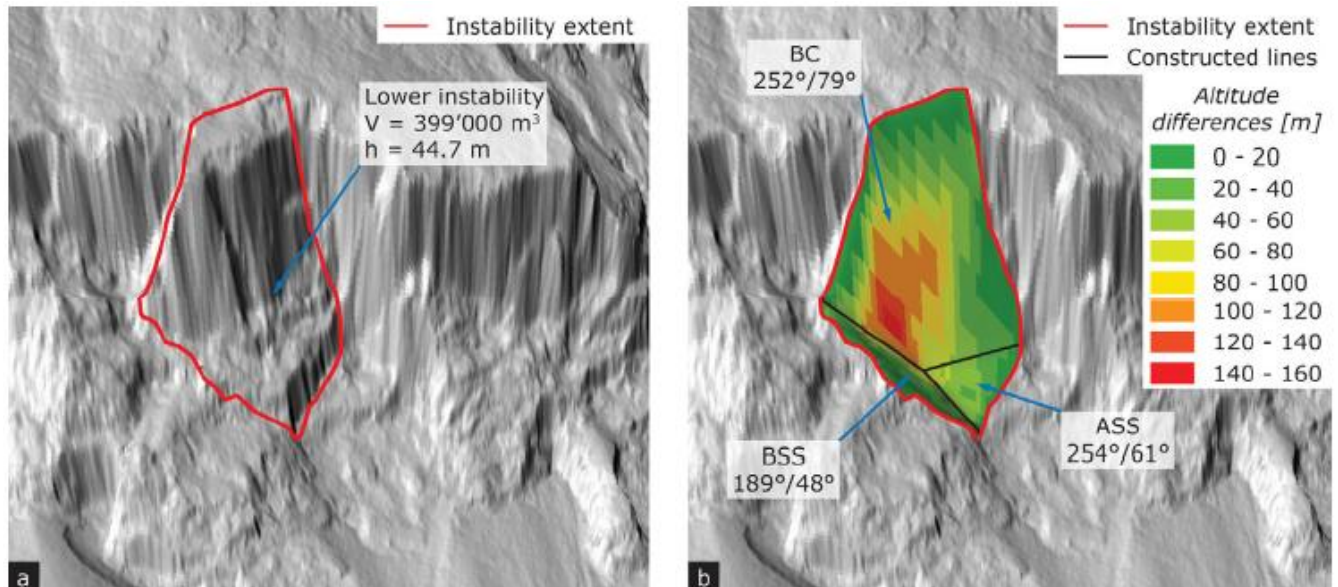
The lower instability is characterized by a large opening along a back-crack in the northern part (Figure 2). The opening is probably mostly developed by rockfall activity along the highly fractured zone. The back-crack is not visible in the continuation to the south. Water seepage has been observed at the base of the instability (Oppikofer, 2010). The volume of the lower instability has been estimated to be 0,4 mill m³ (Figure 4). Good results were obtained from repeated LIDAR measurements, but a possible movement on the site is smaller than the resolution of the method. A rockfall that occurred between the two datasets from 2007 and 2008, above the open crack, was documented by this method (Oppikofer, 2010).

FIGURE 4: 3D VIEWS OF THE LOWER HEGGURAKSLA INSTABILITY (FROM OPPIKOFER, 2010): A) PRESENT TOPOGRAPHY AND INSTABILITY EXTENT; B) ALTITUDE DIFFERENCES BETWEEN THE CONSTRUCTED BASAL FAILURE SURFACE AND THE TOPOGRAPHY (UP TO 143 M).
